**Flood Control Project Maintenance  
Levee Inspections**

**Fall 2018 Levee Maintenance Deficiency Summary Report**

**Reclamation District No. 0755 Randall**

Waterway			Bank	Unit Miles
Unit No. 01 Sacramento River			Left	1.83
	Spring (March - May)	Summer (June - August)	(September - November) Fall	Winter (December - February)
Unit Maintenance Rating (Fall Only)			<b>U</b>	
Date of Inspection	3/21/2018 - 3/21/2018		10/5/2018 - 10/5/2018	
DWR Inspector	Keith Millard		David Julian	
Accompanied By

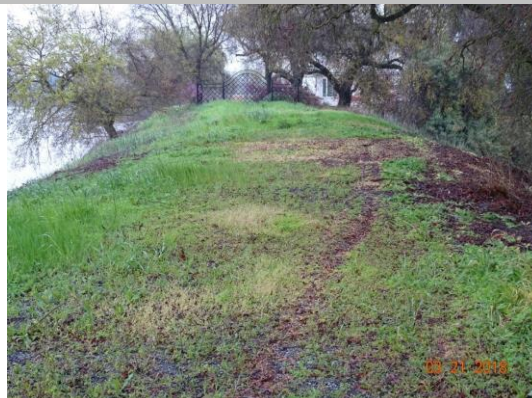
Photo 1 of 1 : FA\_2018\_RD0755\_177\_11\_20180925\_00001.jpg

Crown vegetation should be reduced.

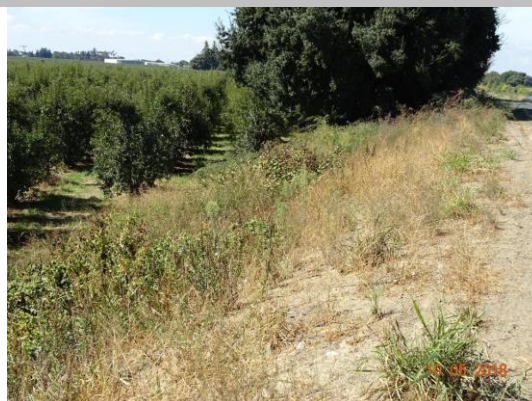
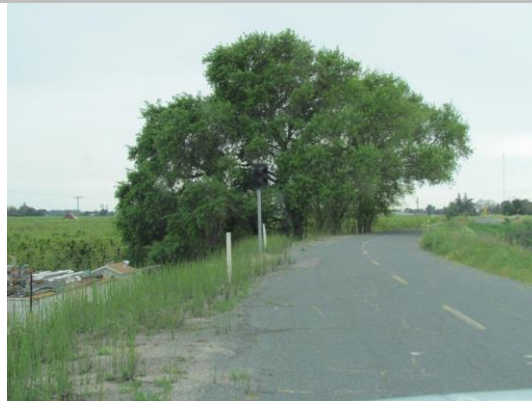
View looking downstream at vegetation on the land side slope (October 2018).

LM Start	<b>0.17</b>	Rating **	M	Issue No.	<b>20 (cont)</b>
LM End	<b>1.05</b>	Issue Type +	Ma	Location *	LS

RD 755 looking downstream from levee mile 0.17-0.59.

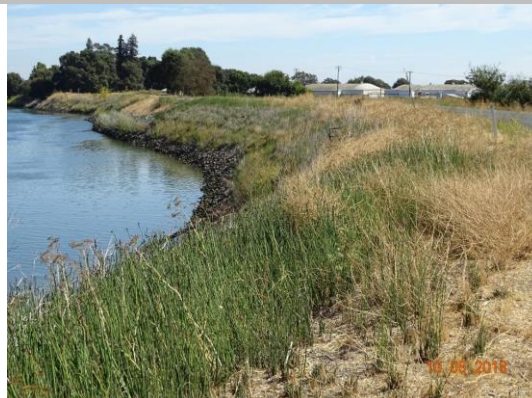
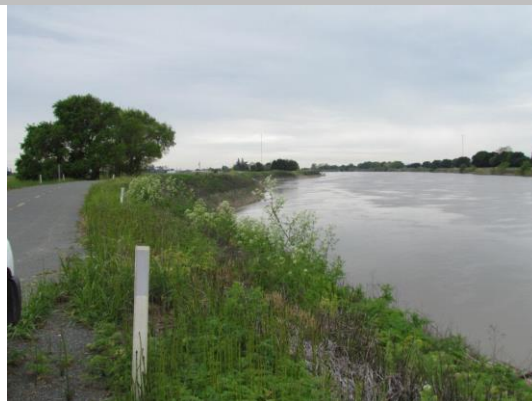
View looking upstream at vegetation on the water side slope (October 2018)

LM Start	<b>0.17</b>	Rating **	M	Issue No.	<b>19 (cont)</b>
LM End	<b>1.84</b>	Issue Type +	Ma	Location *	WS

RD 755 Levee mile 0.17-1.12 waterside looking downstream.

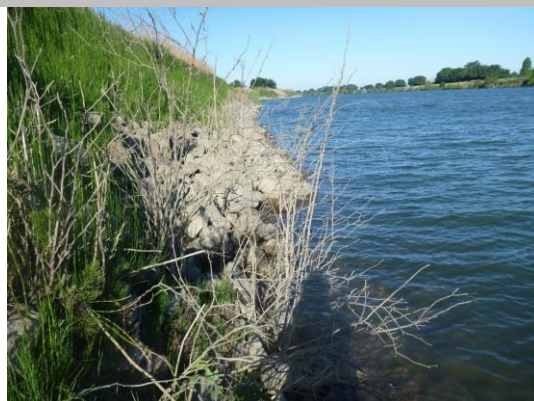
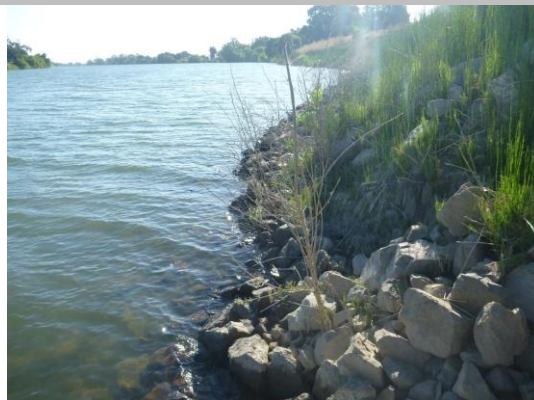
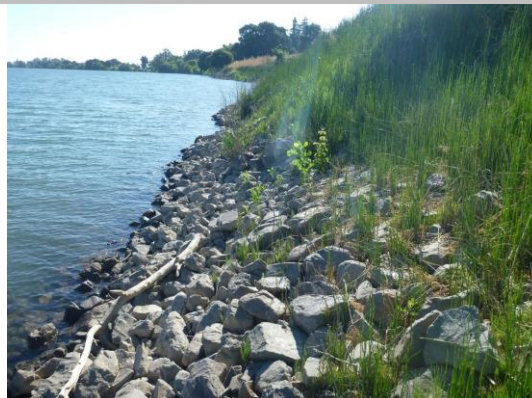
LM Start	0.28	Rating **	A/W	Issue No.	18
LM End	0.28	Issue Type +	Ma	Location *	WS
Category	Supplemental			GPS Latitude/Longitude	
				Start	End
Item	2017 Storm Damage		38.346249 °	38.346331 °	
			-121.540542 °	-121.540664 °	
DWR ID	DWR_RD0755_01_f_2017_18

Comment Code					
Inspector Comment					
Levee Evaluation Comments					
Description:The damage consists of erosion of the lower waterside levee slope and bank approximately 27 feet in length along the east (left) bank of the Sacramento River. See attached pages for photos.					
Site location T06N R04E Section 28.					
Site ID No:327					
Site Designation:LMA-154					
Repair Type: Erosion					
Rating:Area of Concern					
Field Date:7/13/2017					
Notes: Pretty minor damage visible from the slope, site was originally identified by boat. Will look at again from waterside if there is time.					
Crown is a paved road. Original GPS was a little off, added correct point in start

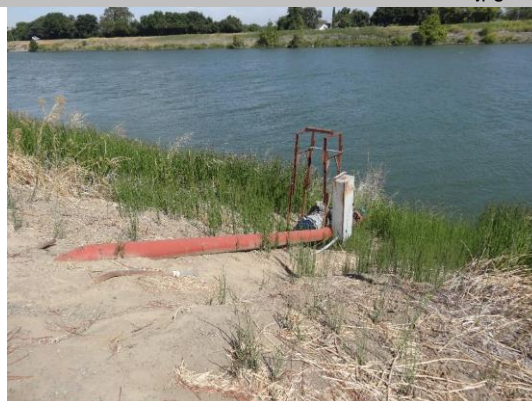
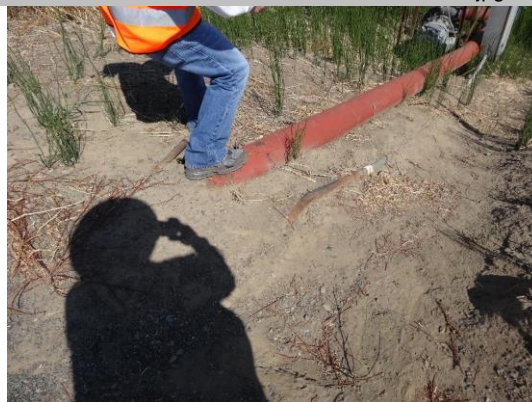
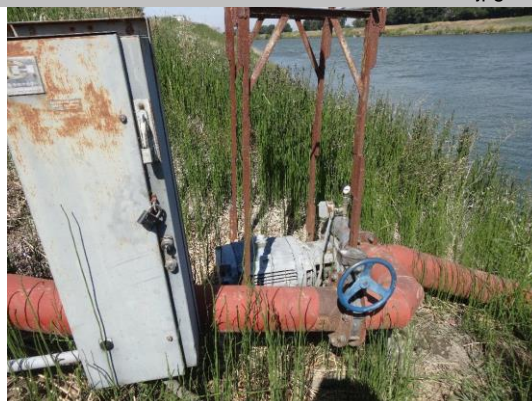
Comment Code					
Inspector Comment					
FS_ID:17123 DS_ID:18849 EP_NO: 4302 Repair Type: Non-Urgent Crossing Status: Found UCIP Comments: FBC about 2 feet.Power conduit also through the levee.Wet ground on pump site/location. May need investigation about wet ground. FIELD_STRUCT_DESC: 8-inch coated steel irrigation discharge pipe through the levee, 2 feet below the crown. Pump, electrical box, and control valve on the waterside (WS) slope. Siphon breaker on the landside (LS) slope. Service pole at the LS toe. (Plans for placing an 8-inch irrigation pipe and pump authorized under Permit No. 4302, 1963 - E. C. Hemly). [Additional Reference(s): DWR Levee Log, 2005, referenced as 4 feet below the crown]. FS Date: 8/6/2013

WS view: overview of pump and pipe.

WS view: steel pipe and power conduit.

WS view: pump, power switch box, butterfly valve and pipe.

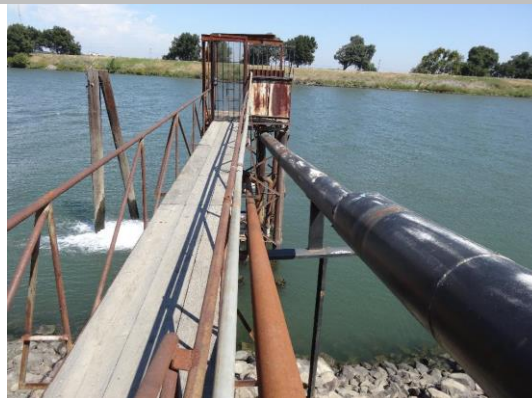
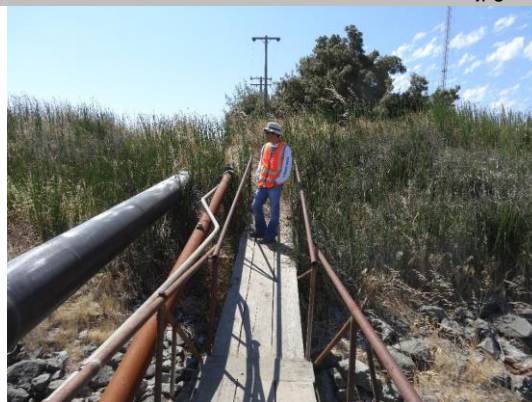
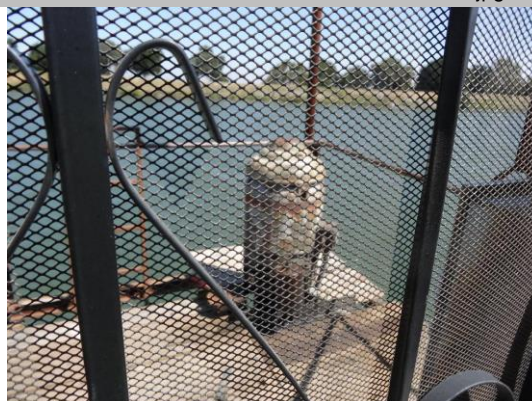
Comment Code						
Inspector Comment						
FS_ID:41634						
DS_ID:18851						
EP_NO: 7357						
Repair Type: Non-Urgent						
Crossing Status: Found						
UCIP Comments: An abandoned 12-in steel pipe lying on LS levee slope should be removed.A buried concrete headwall found on LS levee slope should be checked for any pipe or connection.						
FIELD_STRUCT_DESC: 2 of 2: 8-inch pipe sleeved through a 16-inch irrigation discharge pipe of an unknown material through the levee, 4.2 feet below the crown. Pump on the waterside (WS). (Plans to install an additional pump on an existing stand and to connect the discharge pipe to the existing pipe through the levee authorized under Permit No. 7357, 1971 - Green and Keown Farms, Inc). [Additional Reference(s): DWR Levee Log, 2005, 14-inch outer pipe referenced].						
FS Date: 8/6/2013

WS view: pump structure on the stream, conduit, pipes, and walkway.

WS view: view towards levee crown from pump structure.

WS view: pump mounted on pump station/deck.

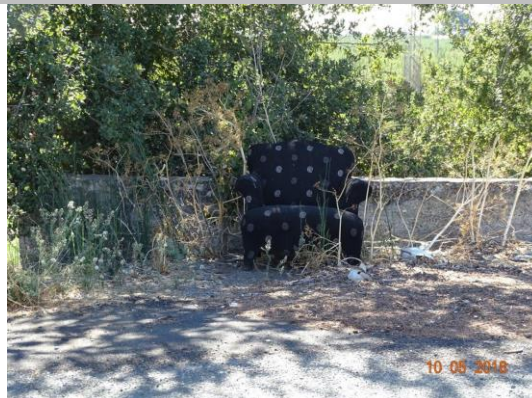
Photo 1 of 1 : FA\_2018\_RD0755\_177\_27\_20181009\_00041.jpg

Chair on the water side (October 2018).

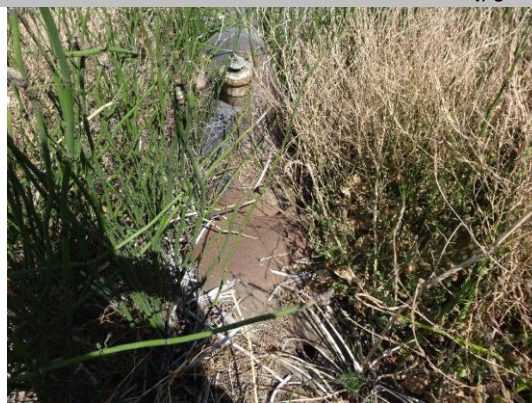
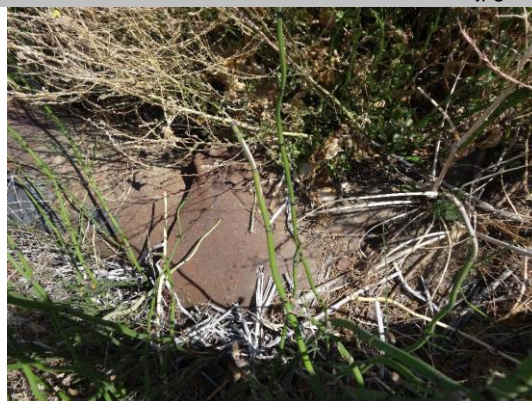
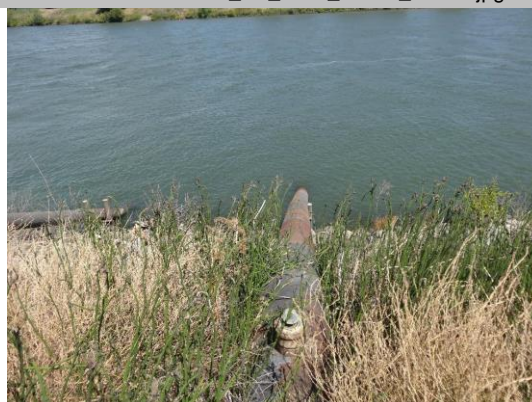
Comment Code						
Inspector Comment						
FS_ID:17145 DS_ID:18852 EP_NO: 11222 Repair Type: No Action Needed Crossing Status: Found UCIP Comments: It was working during field survey. A pump found 150 ft from the levee. Not sure whether the pump belong to this drainage system. FIELD_STRUCT_DESC: *ABANDONED* 16-inch steel drainage pipe sleeved through a 24-inch steel drainage pipe through the levee, invert elevation 8 feet below the crown. (Retention of a 12-inch drainage pipe sleeved through a 24-inch pipe through the levee, 8 feet below the crown, authorized under Automatic Board Order (ABO) issued as Permit No. 11222, 1975 - Green McKeown, Inc). [Additional Reference(s): DWR Levee Log, 2005, 12-inch inner pipe referenced. USACE Sacramento O&M Manual 111, May 1959, (RM 35.89)]. FS Date: 8/6/2013

WS view: pipe and siphon breaker on levee slope

WS view: 16-inch pipe sleeved through 24-inch pipe.

WS view: 16-inch drainage pipe on levee slope.

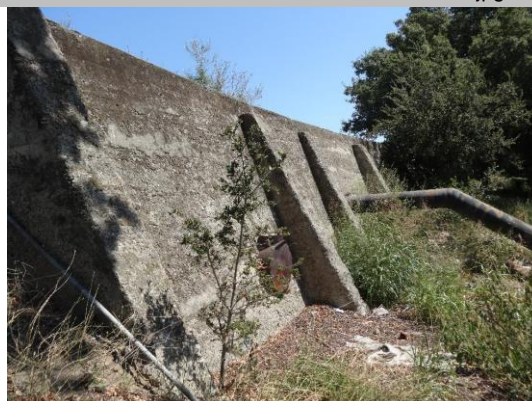
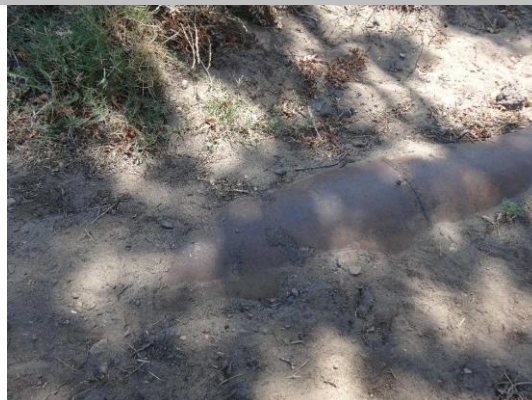
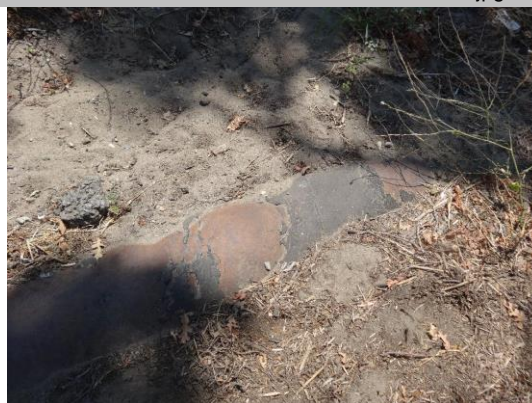
Comment Code					
Inspector Comment					
FS_ID:17049					
DS_ID:18854					
EP_NO: 1716					
Repair Type: Non-Urgent					
Crossing Status: Found					
UCIP Comments: Not found- a 4-inch pipe on waterward shoulder but a 2-inch GI pipe found on landside slope.					
FIELD_STRUCT_DESC: *ABANDONED* 18-inch drainage pipe of an unknown material through the levee, invert elevation 4.5 feet below the crown. (Plans for the replacement of an existing pipe through the levee authorized under Permit No. 1716, 1952 - Reclamation District No. 755 [RD0755]). [Additional Reference(s): DWR Levee Log, 2005. USACE Sacramento O&M Manual 111, May 1959, (RM 35.88)].					
FS Date: 8/6/2013

LS view: concrete headwall and 2-inch conduit (left)

LS view: 18-inch abandoned pipe on levee slope

LS view: exposed/daylight 18-inch abandoned pipe on levee slope

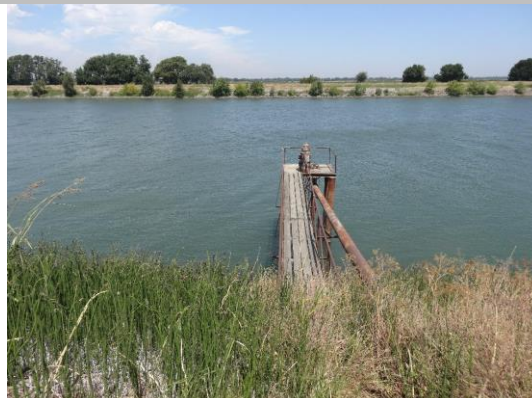
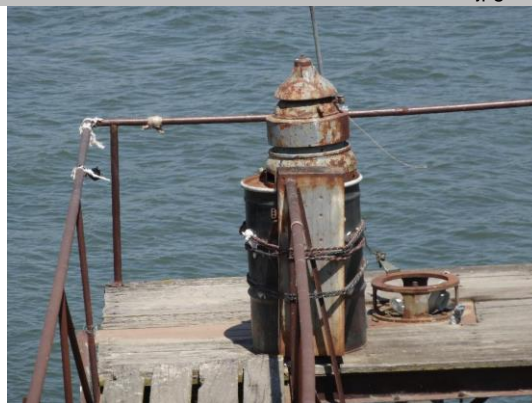
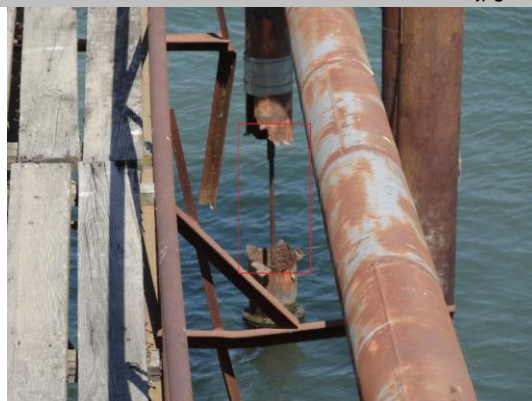
Comment Code					
Inspector Comment					
FS_ID:17063 DS_ID:18855 EP_NO: 11225 Repair Type: Non-Urgent Crossing Status: Found UCIP Comments: Abandoned pipe and pump.Service pole, power box lying on LS slope. FIELD_STRUCT_DESC: *ABANDONED* 10-inch irrigation discharge pipe of an unknown material and a 1-inch electrical conduit through the levee, invert elevation 5.6 feet below the crown. Pump on a pile structure with a walkway to the pump. Abandoned service pole on the landside (LS) slope. (Retention of a 10-inch pipe through the levee, 5.6 feet below the crown, pump on a pile structure with a walkway to the pump, and a service pole on the LS slope Automatic Board Order (ABO) issued as Permit No. 11225, 1975 - Helen D. Wilson). [Additional Reference(s): DWR Levee Log, 2005. USACE Sacramento O&M Manual 111, May 1959, (RM 35.66)]. FS Date: 8/6/2013

WS view: overview of pipe and pump structure.

WS view: an abandoned pump

WS view: abandoned and discontinued vertical intake pipe

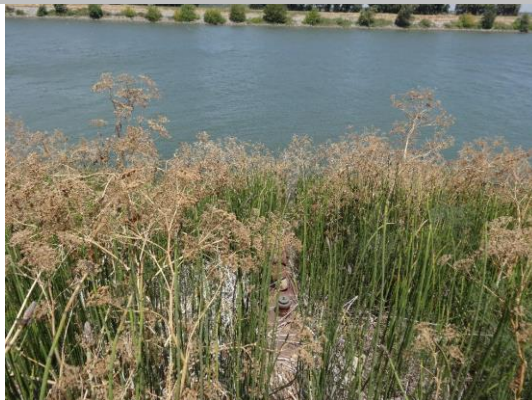
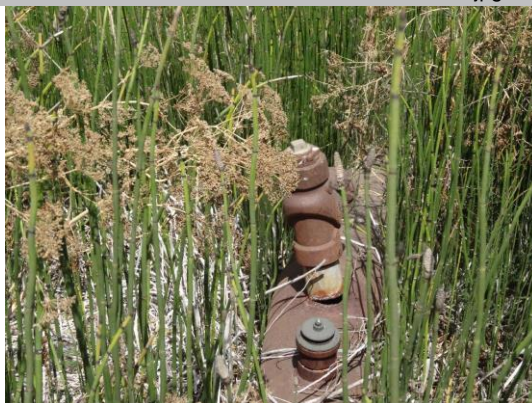
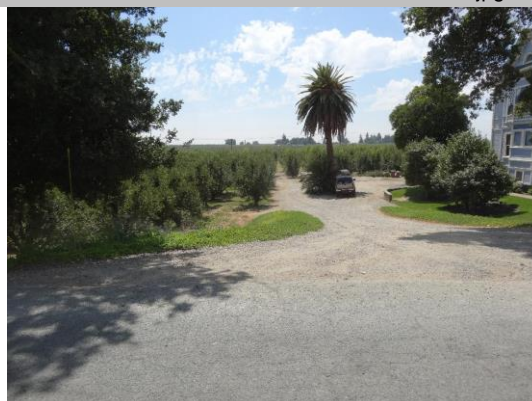
LM Start	1.04	Rating **	M	Issue No.	36
LM End	1.04	Issue Type +	En	Location *	
Category	Supplemental			GPS Latitude/Longitude	
				Start	End
Item	DWR UCIP Field Study			38.343625 °	38.343625 °
				-121.554145 °	-121.554145 °
DWR ID	18856				
Comment Code					
Inspector Comment					
FS_ID:46764					
DS_ID:18856					
EP_NO: N/A					
Repair Type: Non-Urgent					
Crossing Status: Found					
UCIP Comments: Needs to be properly abandoned.					
FIELD_STRUCT_DESC: *ABANDONED* 12-inch pipe of an unknown material or purpose through the levee, invert elevation 5 feet below the crown. Siphon breaker on the waterside (WS). Pipe not found on the landside (LS). (Wilson). [Additional Reference(s): DWR Levee Log, 2005. USACE Sacramento O&M Manual 111, May 1959, (RM 35.55)].					
FS Date: 8/6/2013

WS view: overview of steel pipe with siphon breaker on levee slope

WS view: steel pipe with siphon breaker on levee slope

LS view: no pipe and pump found on LS.

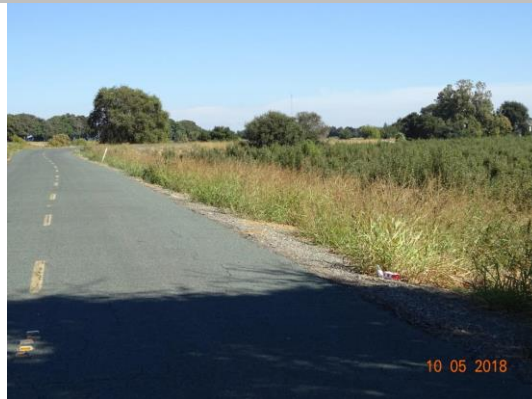
Photo 1 of 1 : FA\_2018\_RD0755\_177\_28\_20181009\_00042.jpg

View looking upstream at vegetation on the land side slope (October 2018).

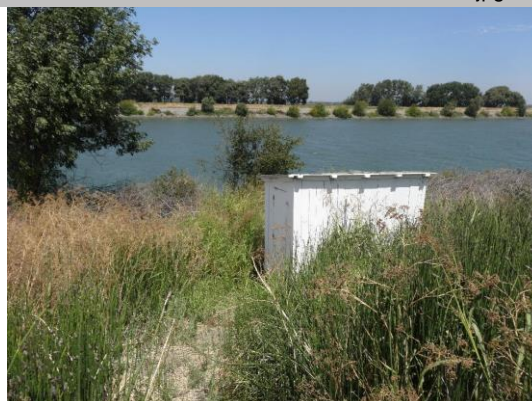
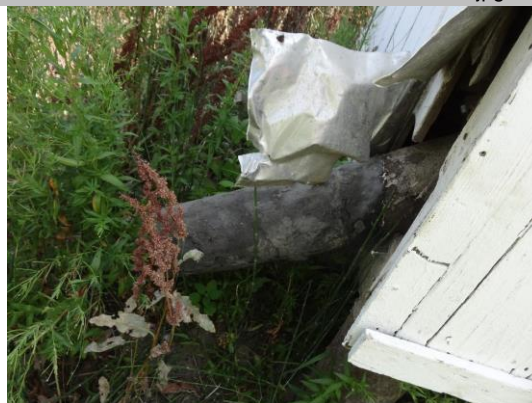
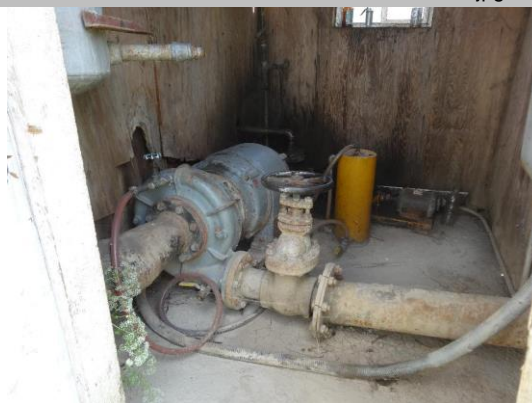
Comment Code					
Inspector Comment					
FS_ID:17144 DS_ID:18857 EP_NO: 11219 Repair Type: Non-Urgent Crossing Status: Found UCIP Comments: - requires cleaning of siphon breaker box. FIELD_STRUCT_DESC: 8-inch irrigation discharge pipe of an unknown material through the levee, invert elevation 5.7 feet below the crown. Siphon breaker in a corrugated metal pipe (CMP) riser on the landside (LS) shoulder. Power pole on the LS. Pump and power box in a pump house on the waterside (WS) slope. Electrical conduit through the levee at the same location. (Retention of an 8-inch pipe through the levee, 5.7 feet below the crown, and a pump in a pump house on the WS slope authorized under Automatic Board Order (ABO) issued as Permit No. 11219, 1975 - David J. Jr and Bonnie Elliott). [Additional Reference(s): DWR Levee Log, 2005. USACE Sacramento O&M Manual 111, May 1959, (RM 35.47)]. FS Date: 8/6/2013

WS view: pump house on levee slope.

WS view: pipe daylight from pump house.

WS view: pumps, butterfly valve and pipe inside pump house.

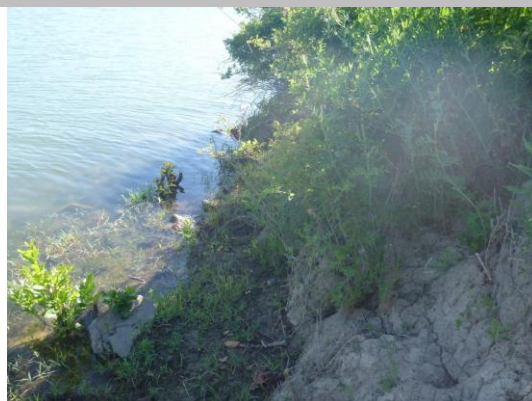
Photo 3 of 3 : FA\_2018\_RD0755\_177\_22\_20180925\_00010.jpg

LM Start	1.23	Rating **	A/W	Issue No.	22 (cont)
LM End	1.29	Issue Type +	Ma	Location *	WS
Category	Supplemental			GPS Latitude/Longitude	
				Start	End
Item	2017 Storm Damage			38.342992°	38.342633°
				-121.557572°	-121.558622°
DWR ID	DWR_RD0755_01_f_2017_22

Comment Code					
Inspector Comment					
Levee Evaluation Comments					
Description:The damage consists of erosion of the lower waterside levee slope and bank approximately 322 feet in length along the east (left) bank of the Sacramento River. See attached pages for photos.					
Site location T06N R04E Section 29.					
Site ID No:328					
Site Designation:LMA-155					
Repair Type: Erosion					
Rating:Area of Concern					
Field Date:7/13/2017					
Notes: Could not access most of the lower portion of the slope because of vegetation, but there was rip rap just downstream of the site. Looked like it may have been missing on part of the site. Erosion looked like it may be 1/2 the length reported. Crown is a paved road

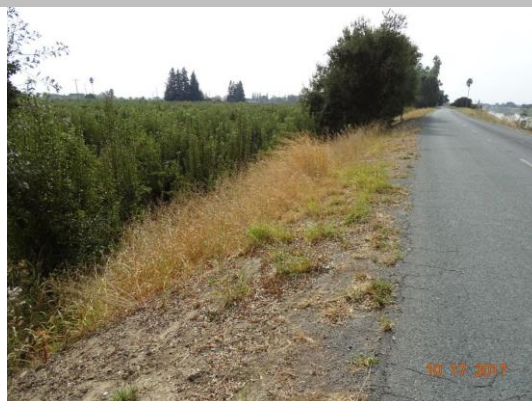
Photo 1 of 1 : FA\_2018\_RD0755\_177\_13\_20180925\_00002.jpg

Vegetation on landside should be maintained to allow inspection and access to slope and toe.

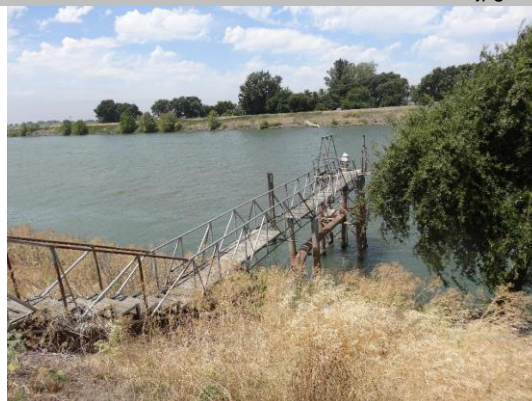
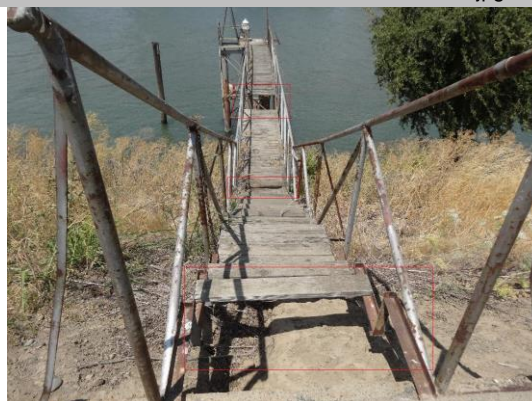
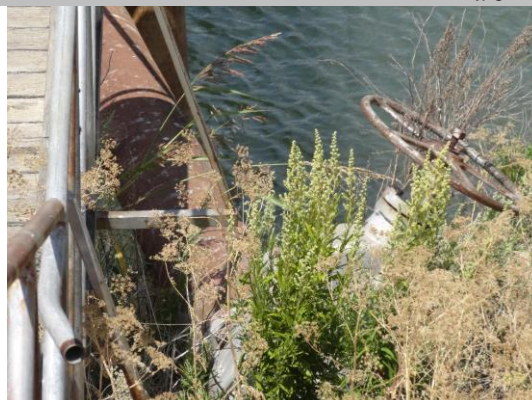
LM Start	1.64	Rating **	M	Issue No.	38	
LM End	1.64	Issue Type +	En	Location *		
Category	Supplemental			GPS Latitude/Longitude		
				Start	End	
Item	DWR UCIP Field Study			38.338715 °	38.338715 °	
				-121.562560 °	-121.562560 °	
DWR ID	18858

WS view: Overview of walkway, pump structure, and pipe.

WS view: Abandoned walkway and pump structure

WS view: Pipe and butterfly/gate valve on levee slope.

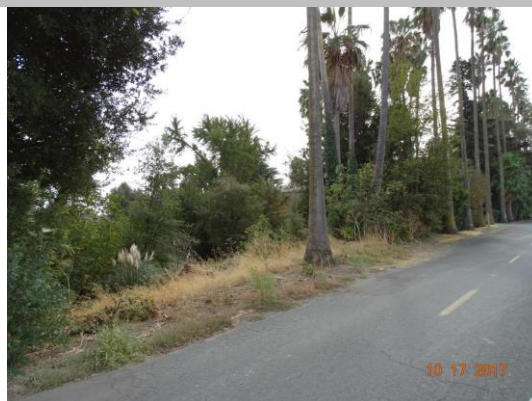
Photo 1 of 1 : FA\_2018\_RD0755\_177\_25\_20180925\_00014.jpg

Landscaping on landside should be maintained to allow inspection and access to levee slope and toe.
